101
C.C.J.J. Commission of Criminal & Juvenile
Justice

Dimension/S F 4 Rehabilitation Zone
Original Use Land
Commissioner

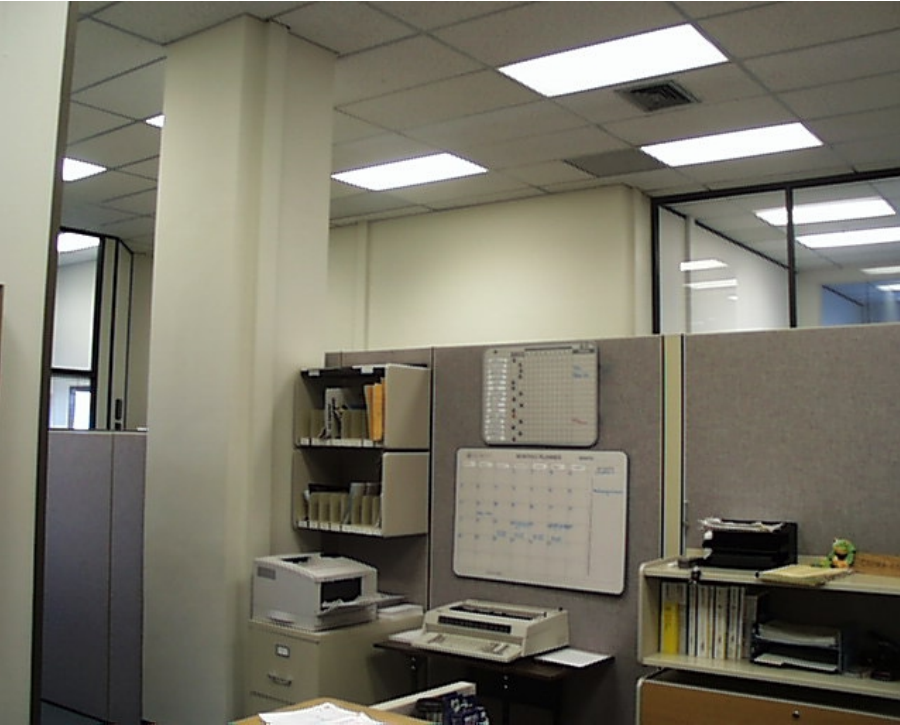
Notes includes 101a

Element	Description	Historical Significance	Notes
CPP-10	Concrete	Contributory Qty: 1	small
D-13	Metal wood-grained panel door with matching casing. Bankers glass panels	Contributory Qty:	with M-21
F-12	Carpeted floor, glue-down	Contributory Qty:	
HC-10	vent	Non-Contributory Qty:	
M-21	Metal casing, new	Non-Contributory Qty:	
M-6	Metal wood-grained casing w/ fancy profile	Non-Contributory Qty:	
W-18	demountable wall	Non-Contributory Qty:	
W-22	Acoustic panel wall, fabric	Non-Contributory Qty:	
W-6	Concrete wall	Non-Contributory Qty:	
WN-1	Aluminum replacement window	Non-Contributory Qty: 4	with M-16
WN-7	Wood transom	Contributory Qty:

WS-2	Marble wainscot, polished	Significant Qty:
B-4	Rubber/vinyl base	Non-Contributory Qty:
B-6	Plaster base, painted	Contributory Qty:
CL-08	Acoustical ceiling, suspended T-bar frame	Non-Contributory Qty:
WN-11	Metal transom, louvered	Non-Contributory Qty:

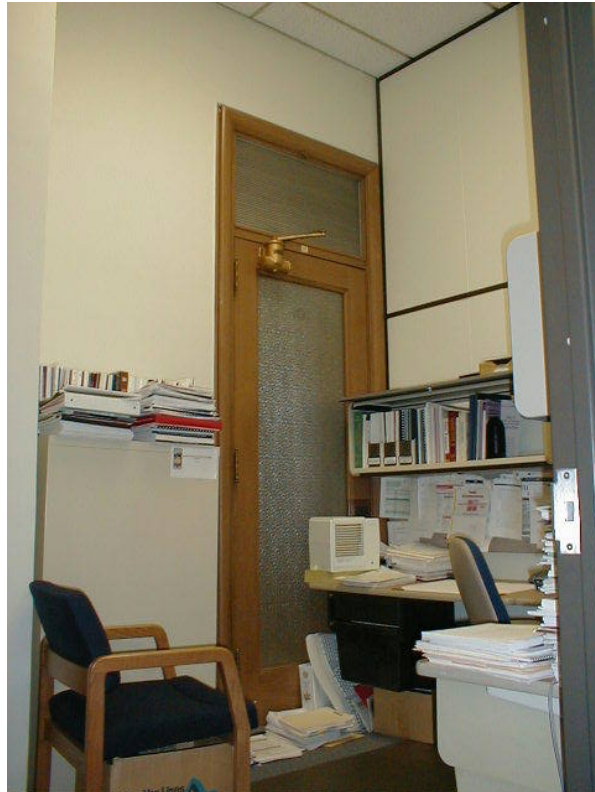
101b CCJJ Office

Element	Description	Historical Significance	Notes
B-4	Rubber/vinyl base	Non-Contributory Qty:	
B-6	Plaster base, painted	Contributory Qty:	
CL-08	Acoustical ceiling, suspended T-bar frame	Non-Contributory Qty:	
CPP-10	Concrete	Contributory Qty:	
D-09	Wood slab door with decorative metal-wood grained casing, transom above	Contributory Qty:	
D-13	Metal wood-grained panel door with matching casing. Bankers glass panels	Contributory Qty:	
F-12	Carpeted floor, glue-down	Contributory Qty:	
HC-10	vent	Non-Contributory Qty:	
M-21	Metal casing, new	Non Contributory Qty:	
M-6	Metal wood-grained casing w/ fancy profile	Non-Contributory Qty:	
W-18	demountable wall	Non Contributory Qty:	
W-22	Acoustic panel wall, fabric	Non Contributory Qty:

W-6	Concrete wall	Non-Contributory Qty:
WN-7	Wood transom	Contributory Qty:
WS-2	Marble wainscot, polished	Significant Qty:

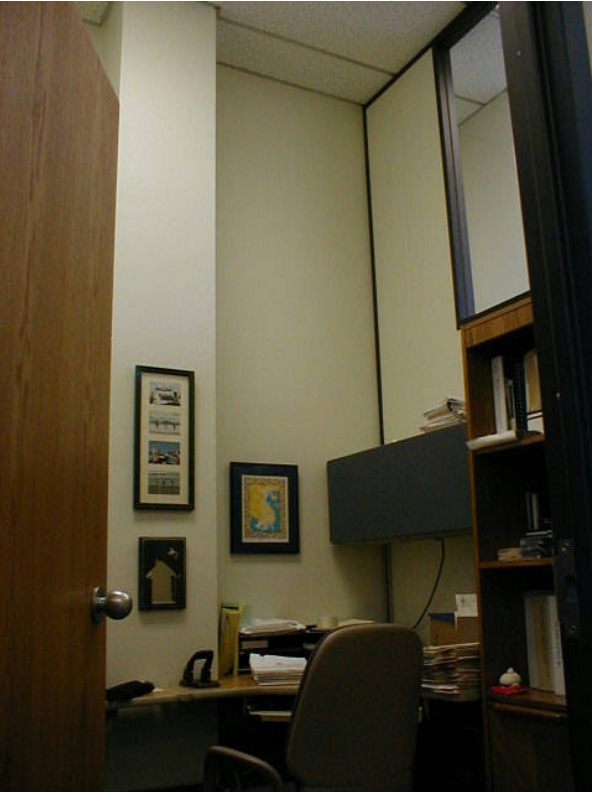
101c CCJJ Office

Element	Description	Historical Significance	Notes
B-4	Rubber/vinyl base	Non-Contributory Qty:	
B-6	Plaster base, painted	Contributory Qty:	
CL-08	Acoustical ceiling, suspended T-bar frame	Non-Contributory Qty:	
CPP-10	Concrete	Contributory Qty:	
D-13	Metal wood-grained panel door with matching casing. Bankers glass panels	Contributory Qty:	
F-12	Carpeted floor, glue-down	Contributory Qty:	
HC-10	vent	Non-Contributory Qty:	
M-21	Metal casing, new	Non Contributory Qty:	
M-6	Metal wood-grained casing w/ fancy profile	Non-Contributory Qty:	
W-18	demountable wall	Non Contributory Qty:	
W-22	Acoustic panel wall, fabric	Non Contributory Qty:	
W-6	Concrete wall	Non-Contributory Qty:

WN-7	Wood transom	Contributory Qty:
WS-2	Marble wainscot, polished	Significant Qty:

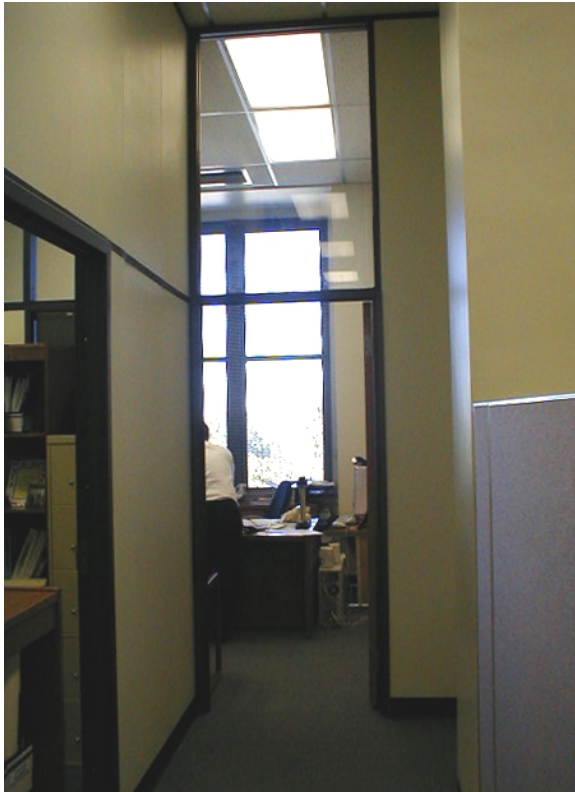
101d CCJJ Office

Notes includes 101 e,f,g

Element	Description	Historical Significance	Notes
B-4	Rubber/vinyl base	Non-Contributory Qty:	
B-6	Plaster base, painted	Contributory Qty:	
CL-08	Acoustical ceiling, suspended T-bar frame	Non-Contributory Qty:	
CPP-10	Concrete	Contributory Qty:	
D-13	Metal wood-grained panel door with matching casing. Bankers glass panels	Contributory Qty:	
F-12	Carpeted floor, glue-down	Contributory Qty:	
HC-10	vent	Non-Contributory Qty:	
HC-6	Thermostat	Non Contributory Qty:	
L-08	Fluorescent lights	Non Contributory Qty:	
M-16	Marble window sill, original, with molded wood skirt	Contributory Qty:	
M-21	Metal casing, new	Non Contributory Qty:	
M-6	Metal wood-grained casing w/ fancy profile	Non-Contributory Qty:

W-18	demountable wall	Non Contributory Qty:
W-22	Acoustic panel wall, fabric	Non Contributory Qty:
W-6	Concrete wall	Non-Contributory Qty:
WN-1	Aluminum replacement window	Non Contributory Qty:
WN-11	Metal transom, louvered	Non-Contributory Qty:
WN-7	Wood transom	Contributory Qty:
WS-2	Marble wainscot, polished	Significant Qty:

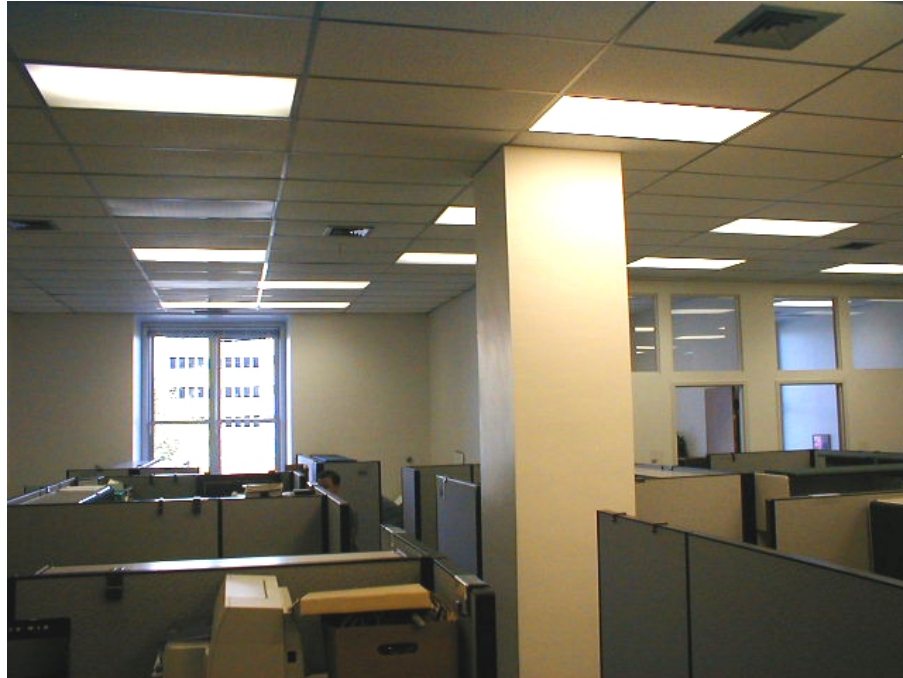
State Auditor's 107/109

Notes Includes 107a,b

Element	Description	Historical Significance	Notes
B-1	Gray marble base, 12" polished	Very Significant Qty:	
B-4	Rubber/vinyl base	Non-Contributory Qty:	
CL-08	Acoustical ceiling, suspended T-bar frame	Non-Contributory Qty:	
CPP-7	Plaster pilaster, painted	Significant Qty:	
D-09	Wood slab door with decorative metal-wood grained casing, transom above	Contributory Qty: 2	with M-6, H-1, WN-11
D-13	Metal wood-grained panel door with matching casing. Bankers glass panels	Contributory Qty:	with m-21
F-12	Carpeted floor, glue-down	Non-Contributory Qty:	
L-08	Fluorescent lights	Non-Contributory Qty:	
W-18	demountable wall	Non-Contributory Qty:	
W-8	Sheetrock wall, painted and smooth	Contributory Qty:	enclosing 107 A,B,C,D
WN-1	Aluminum replacement window	Non-Contributory Qty: 5	with M-16
W-7	Plaster wall, painted and smooth	Very Significant Qty:

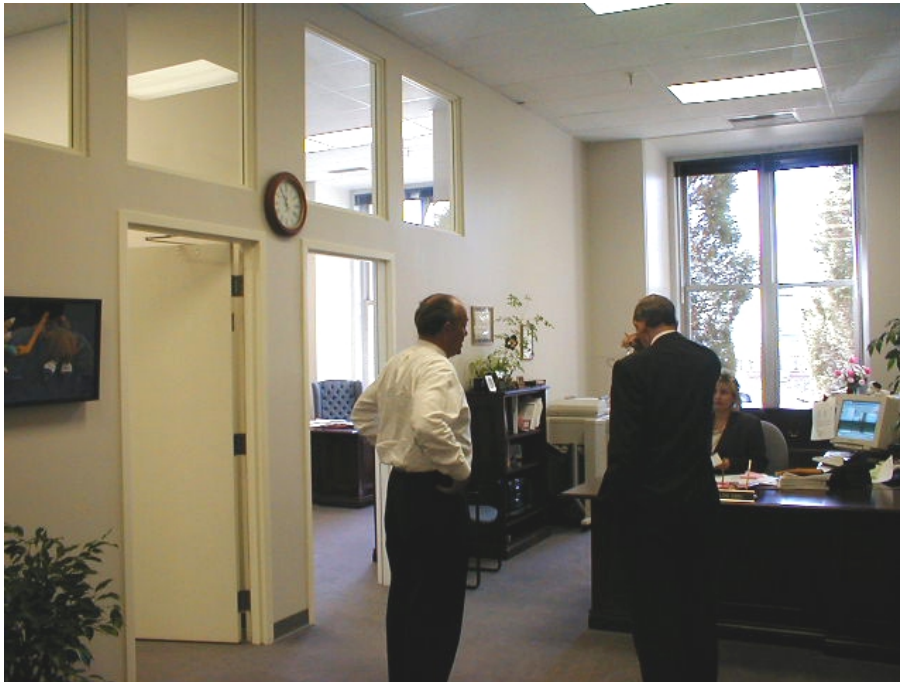
124b Olympic Committee Offices

Notes all new
A 12'-4" x 32'-7"
B 13'-9" x 15'-5"
C 13'-9" x 17'-6"

Element	Description	Historical Significance	Notes
L-08	Fluorescent lights	Non Contributory Qty:	
M-16	Marble window sill, original, with molded wood skirt	Contributory Qty:	
W-8	Sheetrock wall, painted and smooth	Contributory Qty:	
B-4	Rubber/vinyl base	Non-Contributory Qty:	
CL-08	Acoustical ceiling, suspended T-bar frame	Non-Contributory Qty:	
CPP-7	Plaster pilaster, painted	Significant Qty:	
D-13	Metal wood-grained panel door with matching casing. Bankers glass panels	Contributory Qty:	
F-12	Carpeted floor, glue-down	Contributory Qty:	
WN-1	Aluminum replacement window	Non Contributory Qty:

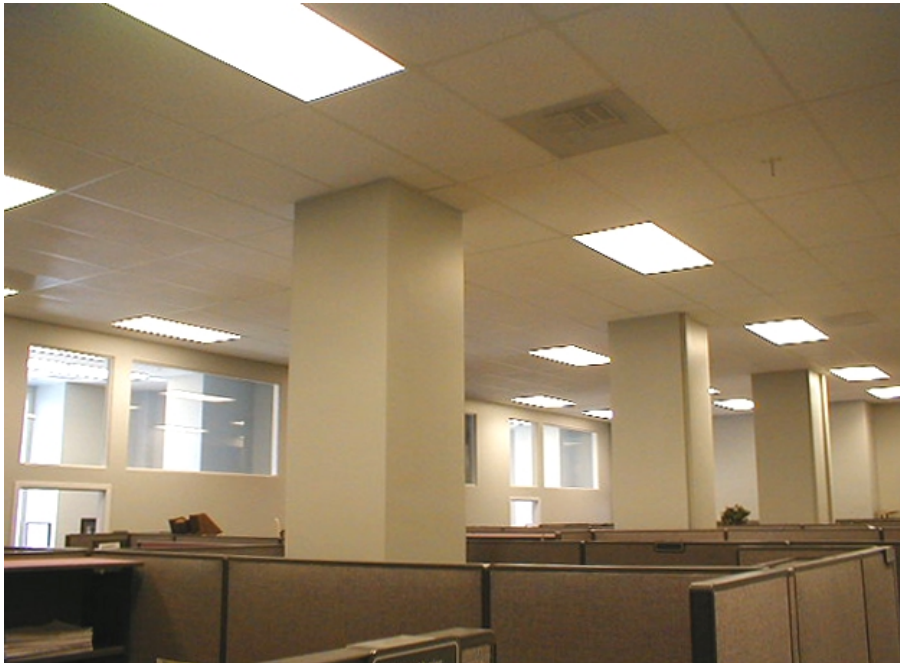
140 Legislative Auditor General

Notes Room is new as of last year (1998-99) columns only original item. Haworth Systems throughout center area. Furniture in offices mostly new - some salvaged throughout the years. Most likely not original. Windows - only thing that could be considered contributory

Element	Description	Historical Significance	Notes
B-1	Gray marble base, 12" polished	Very Significant Qty:	
B-4	Rubber/vinyl base	Non-Contributory Qty:	
CL-08	Acoustical ceiling, suspended T-bar frame	Non-Contributory Qty:	
F-11	Carpeted floor, on pad	Contributory Qty:	
F-12	Carpeted floor, glue-down	Non-Contributory Qty:	
L-08	Fluorescent lights	Non-Contributory Qty:	
W-7	Plaster wall, painted and smooth	Contributory Qty:	
W-8	Sheetrock wall, painted and smooth	Contributory Qty:	
WN-1	Aluminum replacement window	Non Contributory Qty:	
WN-8	Interior sidelight window, metal	Non-Contributory Qty:

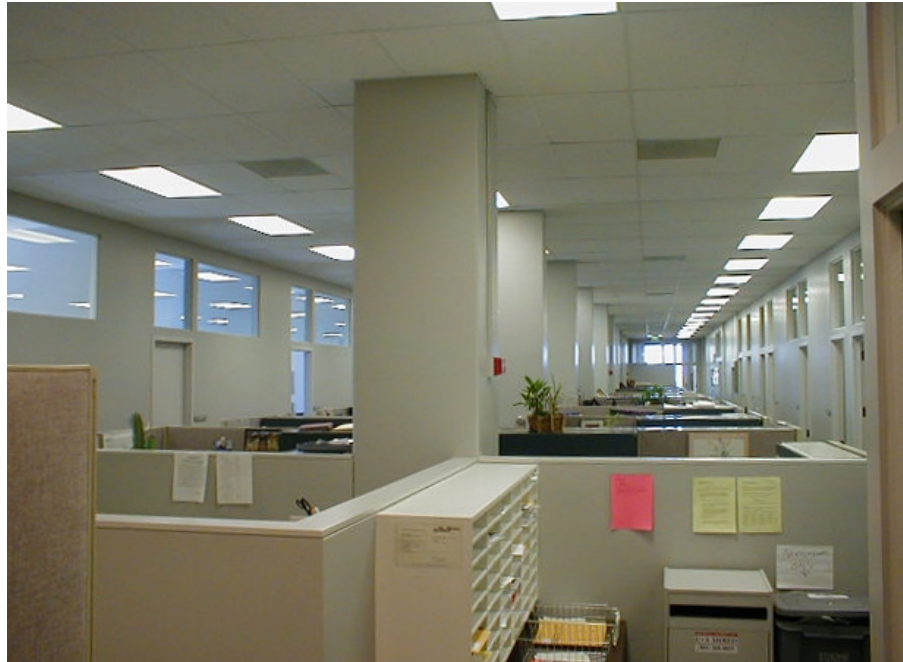
153 G.O.P.B.

Notes Includes 150-152,154-157

Element	Description	Historical Significance	Notes
B-1	Gray marble base, 12" polished	Very Significant Qty:	
B-4	Rubber/vinyl base	Non-Contributory Qty:	
CL-08	Acoustical ceiling, suspended T-bar frame	Non-Contributory Qty:	
D-09	Wood slab door with decorative metal-wood grained casing, transom above	Contributory Qty:	
D-13	Metal wood-grained panel door with matching casing. Bankers glass panels	Contributory Qty:	
F-12	Carpeted floor, glue-down	Contributory Qty:	
H-1	Brass door handle, modern	Contributory Qty:	
L-08	Fluorescent lights	Non Contributory Qty:	
M-16	Marble window sill, original, with molded wood skirt	Contributory Qty:	
M-6	Metal wood-grained casing w/ fancy profile	Non-Contributory Qty:	
W-2	Oolite slab wall, painted	Very Significant Qty:	
W-7	Plaster wall, painted and smooth	Contributory Qty:

WN-1	Aluminum replacement window	Non Contributory Qty:
WN-7	Wood transom	Contributory Qty:

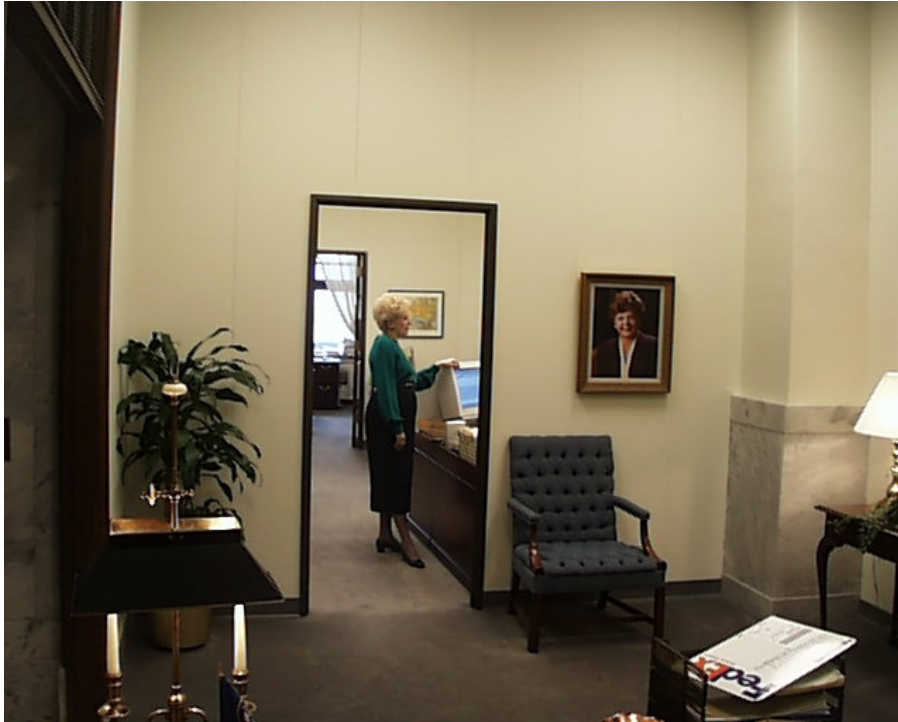
201a

Element	Description	Historical Significance	Notes
B-1	Gray marble base, 12" polished	Very Significant Qty:	south wall - 6" version
B-4	Rubber/vinyl base	Non-Contributory Qty:	
B-7	Marble base block	Significant Qty:	marble threshold (south door) brass on top with WS-9
CPP-7	Plaster pilaster, painted	Significant Qty: 2	
F-11	Carpeted floor, on pad	Contributory Qty:	
L-08	Fluorescent lights	Non-Contributory Qty:	
M-21	Metal casing, new	Non Contributory Qty: 2	
M-6	Metal wood-grained casing w/ fancy profile	Significant Qty: 1	6' opening (South door) needs touch up paint
W-18	demountable wall	Non-Contributory Qty:	
WS-9	Gray marble wainscot, matches coved profile of column base and pedestal	Contributory Qty: 2	on columns

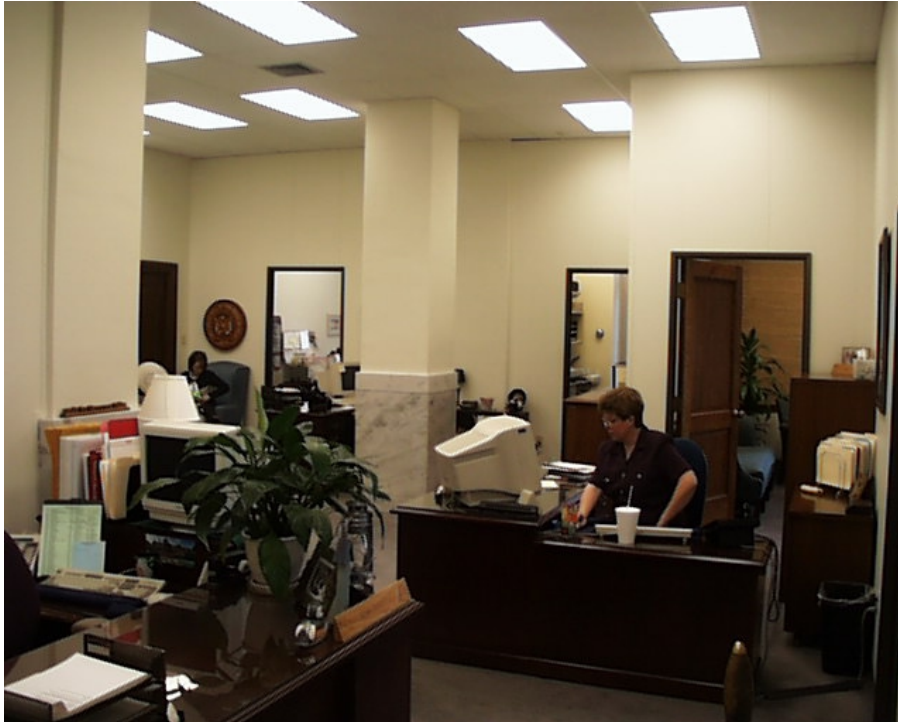
201b

Notes Includes room 201c

Element	Description	Historical Significance	Notes
B-1	Gray marble base, 12" polished	Very Significant Qty:	only on south wall - 6" version
B-4	Rubber/vinyl base	Non-Contributory Qty:	
CL-08	Acoustical ceiling, suspended T-bar frame	Non-Contributory Qty:	
CPP-7	Plaster pilaster, painted	Significant Qty: 3	with WS-9, 3'-11" tall
F-11	Carpeted floor, on pad	Contributory Qty:	
L-08	Fluorescent lights	Non-Contributory Qty: 18	
D-15	Wood slab door with plain wood casing (simple closet/demountable doors)	Non-Contributory Qty: 9	bronze anodized
D-05	Metal wood-grained panel door with matching casing	Contributory Qty: 1	on door to 201
MS-3	Fire hose cabinet, glass, metal, recessed in wall	Non-Contributory Qty: 1	
W-18	demountable wall	Non-Contributory Qty:	
WS-9	Gray marble wainscot, matches coved profile of column base and pedestal	Significant Qty: 3	3'-11" tall on pilasters CPP-7 and columns

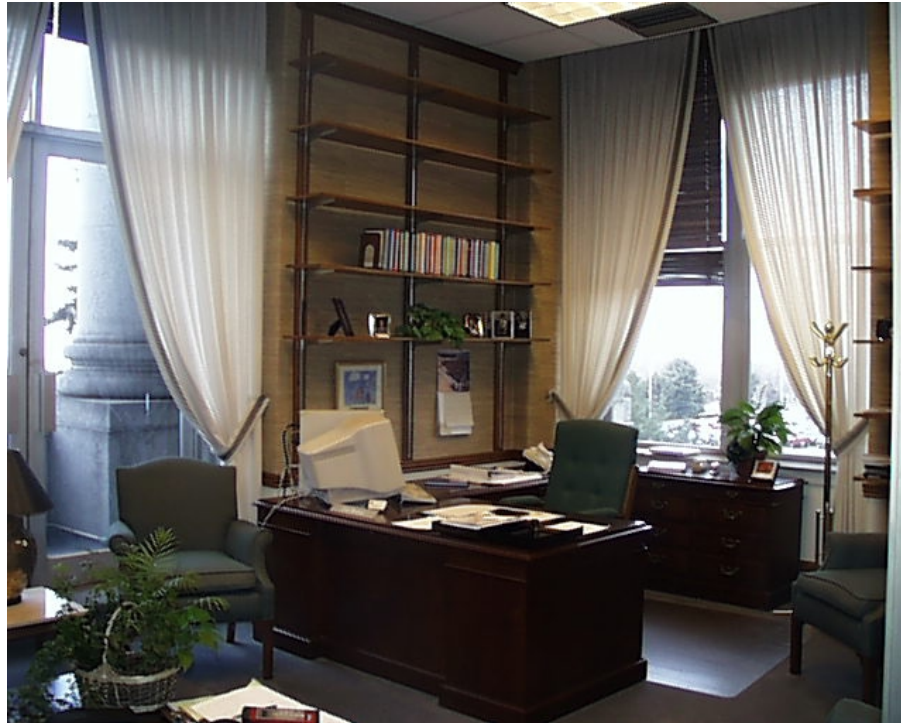
203a

Notes Includes rooms 203b-203d

Element	Description	Historical Significance	Notes
D-30	Aluminum doors with glass panels and matching transoms. Swing doors to patio in corner offices.	Contributory Qty:	
D-08	Wood slab door with decorative metal-wood grained casing	Contributory Qty:	
W-18	demountable wall	Non Contributory Qty:	
B-2	Molded wood base	Contributory Qty:	new, 8" tall
CL-08	Acoustical ceiling, suspended T-bar frame	Non-Contributory Qty:	
CR-5	Wood cornice	Non-Contributory Qty:	not original
D-07	Wood Panel door with decorative metal wood-grained casing	Significant Qty: 2	to balcony KAWNEER 6-1/2" step up to door
D-11	Metal wood-grained panel door with matching casing. Plain louver transom	Contributory Qty: 1	raised double panel
F-11	Carpeted floor, on pad	Contributory Qty:	
H-1	Brass door handle, modern	Contributory Qty: 1	on D-8
HC-10	vent	Non-Contributory Qty: 2

HC-6	Thermostat	Non-Contributory Qty: 2	not working
L-08	Fluorescent lights	Non-Contributory Qty: 6	2 x 4
M-11	Wood chair rail	Non-Contributory Qty:	
W-10	Insulated Fabric wall	Non-Contributory Qty:	natural fiber (non-insulated) horizontal pattern
W-7	Plaster wall, painted and smooth	Contributory Qty:	
WN-1	Aluminum replacement window	Non-Contributory Qty: 2	no casing

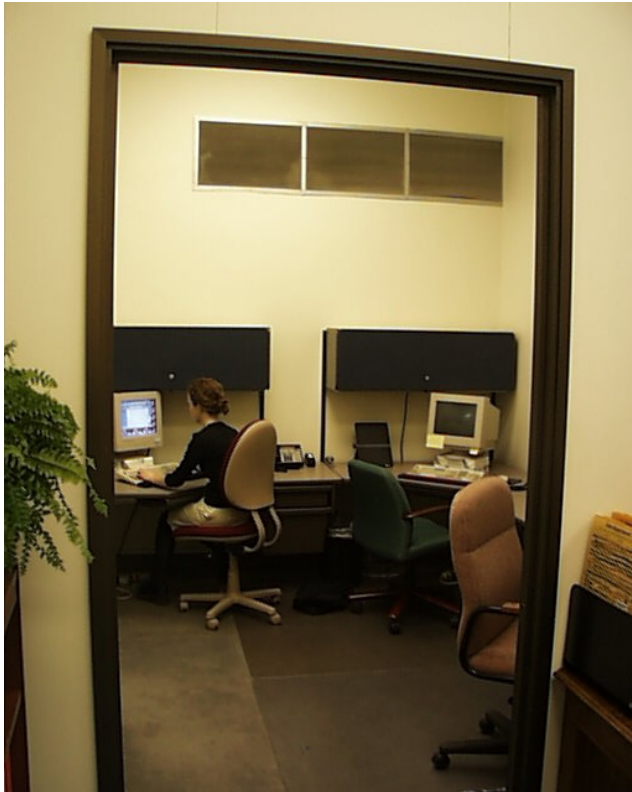
203e Lieutenant Governor - Intern Offices

Notes Office space configured with Systems furniture

Element	Description	Historical Significance	Notes
B-6	Plaster base, painted	Qnty:	
B-4	Rubber/vinyl base	Non-Contributory Qnty:	west wall
CL-08	Acoustical ceiling, suspended T-bar frame	Non-Contributory Qnty:	
F-11	Carpeted floor, on pad	Contributory Qnty:	
HC-10	vent	Non-Contributory Qnty: 3	
L-08	Fluorescent lights	Non-Contributory Qnty: 3	
D-15	Wood slab door with plain wood casing (simple closet/demountable doors)	Non-Contributory Qnty: 2	casing only - no door panels/slabs
W-18	demountable wall	Non-Contributory Qnty:	
W-7	Plaster wall, painted and smooth	Contributory Qnty:	east wall

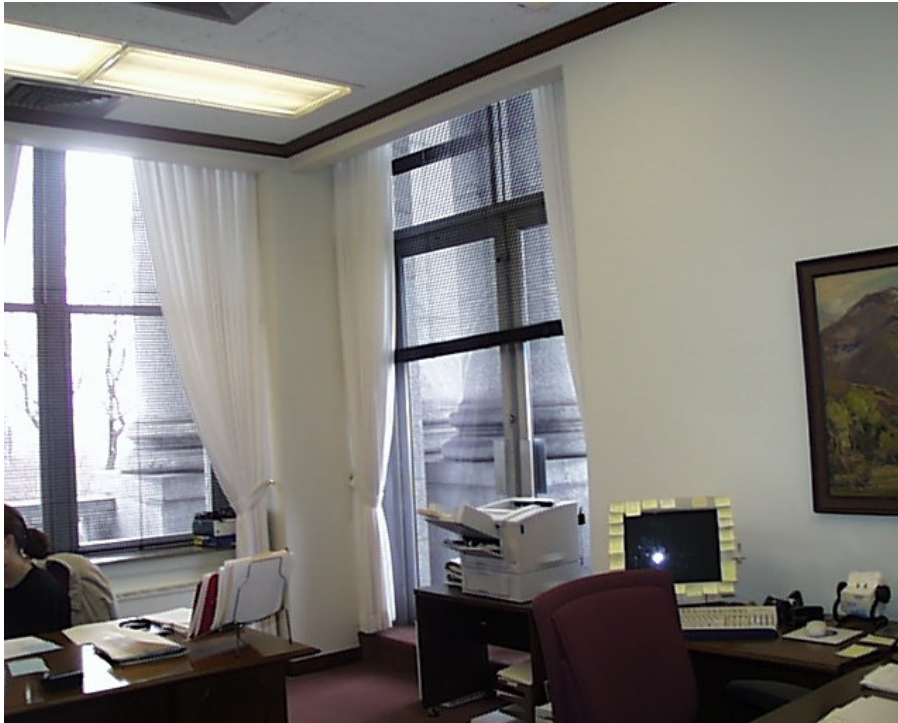
Element	Description	Historical Significance	Notes
B-6	Plaster base, painted	Contributory Qty:	3 1/2"
CR-5	Wood cornice	Non-Contributory Qty:	
D-27	Wood slab door with etched panel look. Plain wood casing, extending up to 1/2 transom. Governor's area specific	Significant Qty: 2	
F-11	Carpeted floor, on pad	Contributory Qty:	
HC-11	fan	Non-Contributory Qty: 1	fan coil unit
HC-13	Heater/Air Conditioner, fan coil	Non-Contributory Qty:	
HC-14	Return vent	Non-Contributory Qty: 2	
L-08	Fluorescent lights	Non-Contributory Qty: 6	
W-4	Wood panelled wall	Contributory Qty:	north wall (with closet/door) and brass "tracks"
W-7	Plaster wall, painted and smooth	Contributory Qty:	
WN-1	Aluminum replacement window	Non-Contributory Qty: 2	with M-16
W-8	Sheetrock wall, painted and smooth	Contributory Qty:

D-30	Aluminum doors with glass panels and matching transoms. Swing doors to patio in corner offices.	Contributory Qty:	Specific to 206
B-2	Molded wood base	Contributory Qty:	Stain
CL-08	Acoustical ceiling, suspended T-bar frame	Contributory Qty:

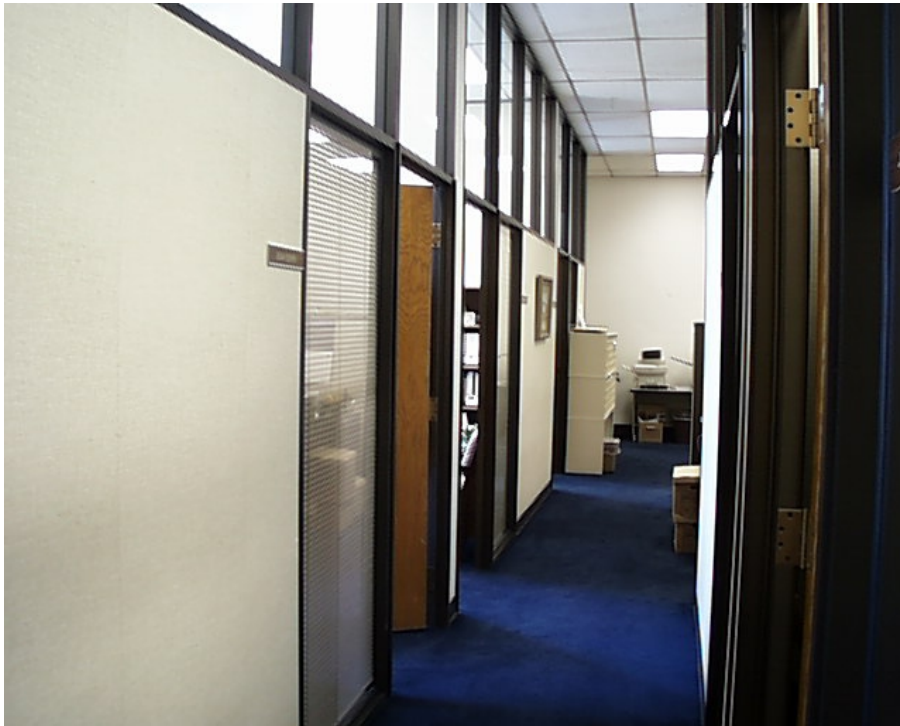
207 Auditors 207/211

Notes includes 207a & 208a thru 208d. Room 208 d was originally used as restrooms

Element	Description	Historical Significance	Notes
B-6	Plaster base, painted	Very Significant Qty:	
D-07	Wood Panel door with decorative metal wood-grained casing	Significant Qty:	
D-18	Metal wood-grained panel door with matching casing. Plain louver transom	Significant Qty:	Entrance to/from main hall, with marble threshold
B-4	Rubber/vinyl base	Non Contributory Qty:	
CL-08	Acoustical ceiling, suspended T-bar frame	Non Contributory Qty:	
D-19	Wood slab door with plain metal casing. (demountable wall doors)	Significant Qty:	
F-12	Carpeted floor, glue-down	Contributory Qty:	
H-3	Brass door handle, old or original	Very Significant Qty:	
L-08	Fluorescent lights	Non Contributory Qty:	
W-18	demountable wall	Non Contributory Qty:	
W-7	Plaster wall, painted and smooth	Contributory Qty:	
WN-1	Aluminum replacement window	Non Contributory Qty:	Variable Element

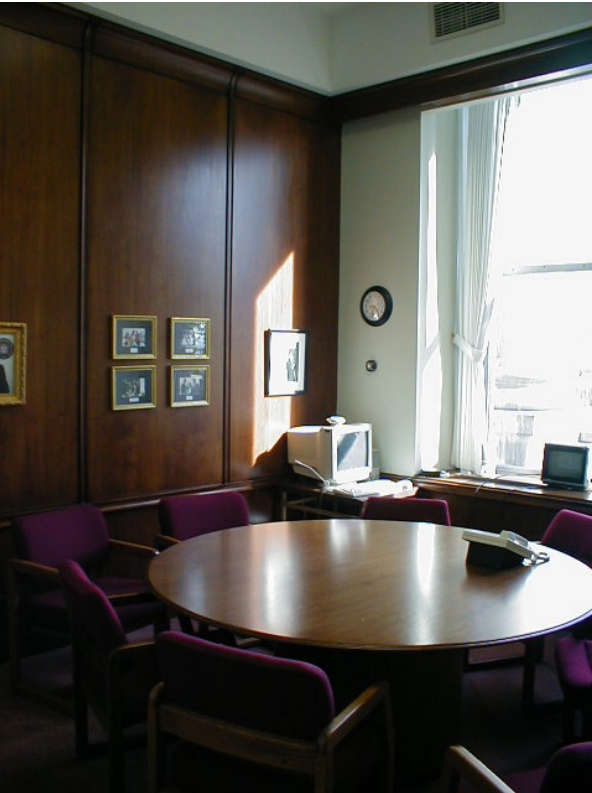
209d Conference Room

perhaps originally one room with 209F/ includes 209e,f & g. 209f Housed the Deputy chief of staff, originally the Governor's business office

Element	Description	Historical Significance	Notes
B-6	Plaster base, painted	Contributory Qty:	
CL-05	Coffered plaster ceiling, beams, ornamental, with molding	Significant Qty:	
CPP-7	Plaster pilaster, painted	Significant Qty:	
CR-5	Wood cornice	Significant Qty:	
D-27	Wood slab door with etched panel look. Plain wood casing, extending up to 1/2 transom. Governor's area specific	Contributory Qty: 1	
E-9	Switch, with non-original plate	Non-Contributory Qty:	
F-11	Carpeted floor, on pad	Contributory Qty:	
HC-10	vent	Non-Contributory Qty:	
L-08	Fluorescent lights	Non-Contributory Qty:	Diffused screen
M-11	Wood chair rail	Non-Contributory Qty:	
W-4	Wood panelled wall	Significant Qty:	
W-8	Sheetrock wall, painted and smooth	Contributory Qty:

WS-4	Oak wainscot	Significant Qty:
HC-15	Duct in fake beam, new, with ornamental grille	Non-Contributory Qty:
HC-6	Thermostat	Non Contributory Qty:
W-7	Plaster wall, painted and smooth	Contributory Qty:

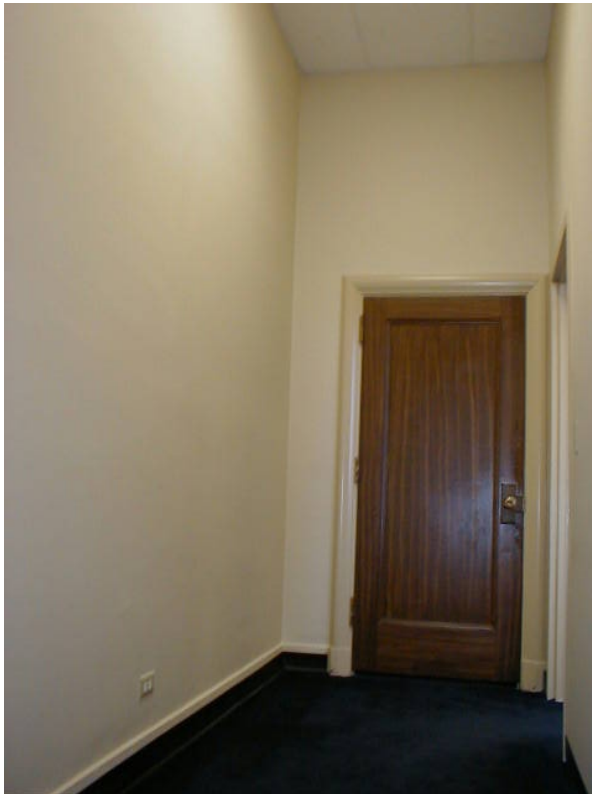
211f Auditors- hallway

Element	Description	Historical Significance	Notes
W-8	Sheetrock wall, painted and smooth	Contributory Qty:	
D-29	Wood panel door with metal wood-grained bollection molding	Significant Qty:	end of hall/ to restroom
D-15	Wood slab door with plain wood casing (simple closet/demountable doors)	Contributory Qty:	To conference room
CL-08	Acoustical ceiling, suspended T-bar frame	Non Contributory Qty:	
D-11	Metal wood-grained panel door with matching casing. Plain louver transom	Contributory Qty:	
L-08	Fluorescent lights	Non Contributory Qty:	
W-7	Plaster wall, painted and smooth	Contributory Qty:	
B-2	Molded wood base	Contributory Qty:	
CL-09	Concrete ceiling	Significant Qty:	
D-15	Wood slab door with plain wood casing (simple closet/demountable doors)	Non Contributory Qty:	
D-23	Wood slab door with decorative wood casing	Significant Qty:	
F-11	Carpeted floor, on pad	Contributory Qty:	
L-08	Fluorescent lights	Non Contributory Qty:

B-6	Plaster base, painted	Significant Qty:	Painted

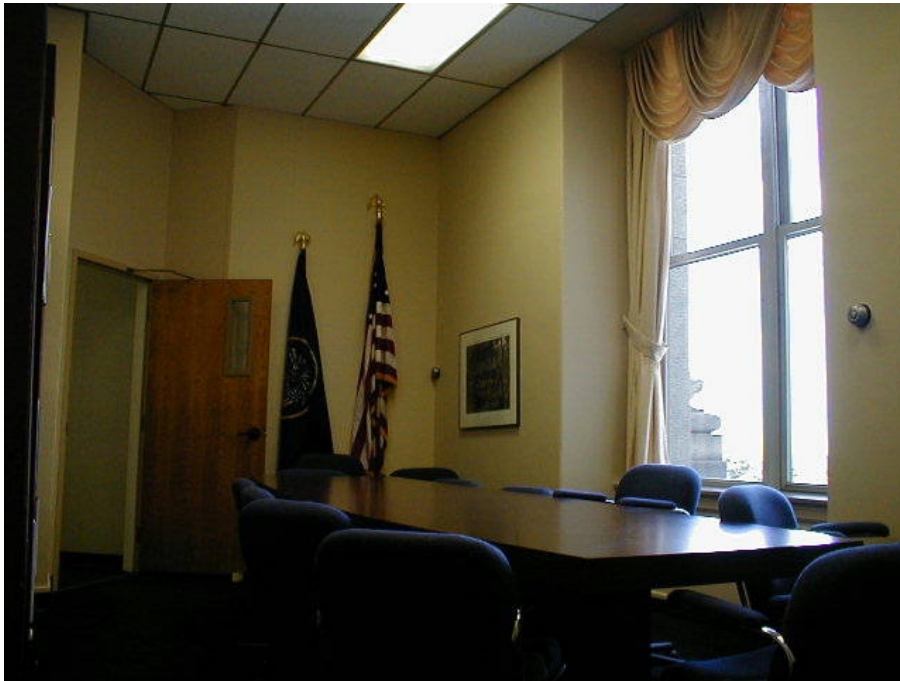
211g Auditors - Conference Room

Element	Description	Historical Significance	Notes
W-18	demountable wall	Non Contributory Qty:	
W-8	Sheetrock wall, painted and smooth	Contributory Qty:	
b-6	Plaster base, painted	Very Significant Qty:	
B-4	Rubber/vinyl base	Non Contributory Qty:	
CL-08	Acoustical ceiling, suspended T-bar frame	Non Contributory Qty:	
D-15	Wood slab door with plain wood casing (simple closet/demountable doors)	Contributory Qty:	
L-08	Fluorescent lights	Non Contributory Qty:	
W-7	Plaster wall, painted and smooth	Contributory Qty:	
WN-1	Aluminum replacement window	Non Contributory Qty:

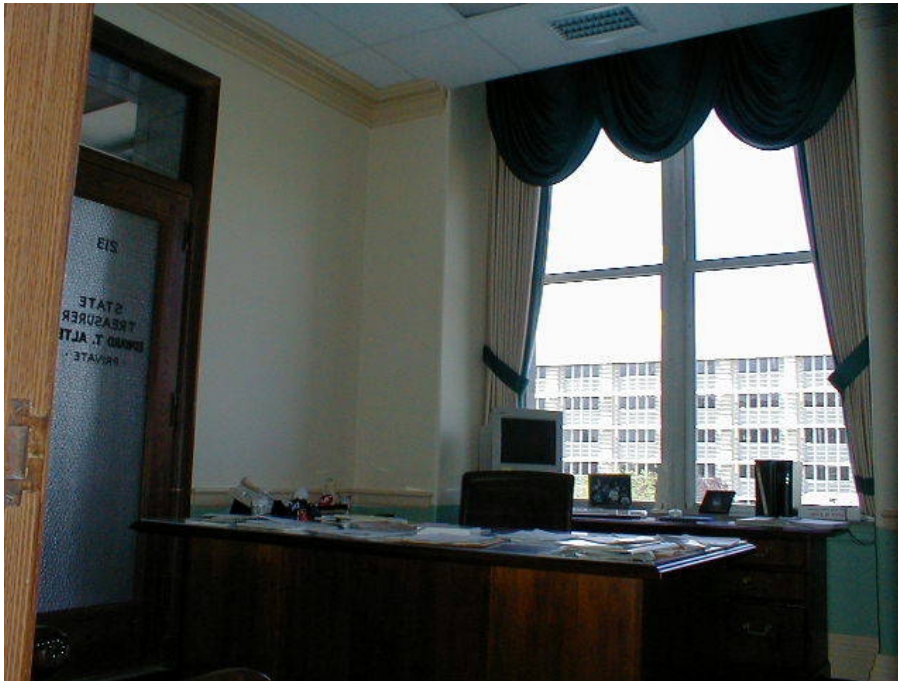
213

Notes Includes 214a,b,c.

Element	Description	Historical Significance	Notes
D-10	Metal wood-grained panel door with matching casing. Bankers glass panel and transom	Very Significant Qty:	
W-7	Plaster wall, painted and smooth	Very Significant Qty:	
B-2	Molded wood base	Contributory Qty:	
CL-08	Acoustical ceiling, suspended T-bar frame	Non Contributory Qty:	
W-8	Sheetrock wall, painted and smooth	Contributory Qty:	
M-11	Wood chair rail	Contributory Qty:	
L-08	Fluorescent lights	Non Contributory Qty:	
D-28	Metal wood-grained panel door with matching bollection molding	Non Contributory Qty:	
F-11	Carpeted floor, on pad	Contributory Qty:	
CL-08	Acoustical ceiling, suspended T-bar frame	Non Contributory Qty:	
F-12	Carpeted floor, glue-down	Contributory Qty:	
L-08	Fluorescent lights	Non Contributory Qty:	
D-10	Metal wood-grained panel door with matching casing. Bankers glass panel and transom	Contributory Qty:	Single
WN-1	Aluminum replacement window	Non Contributory Qty:

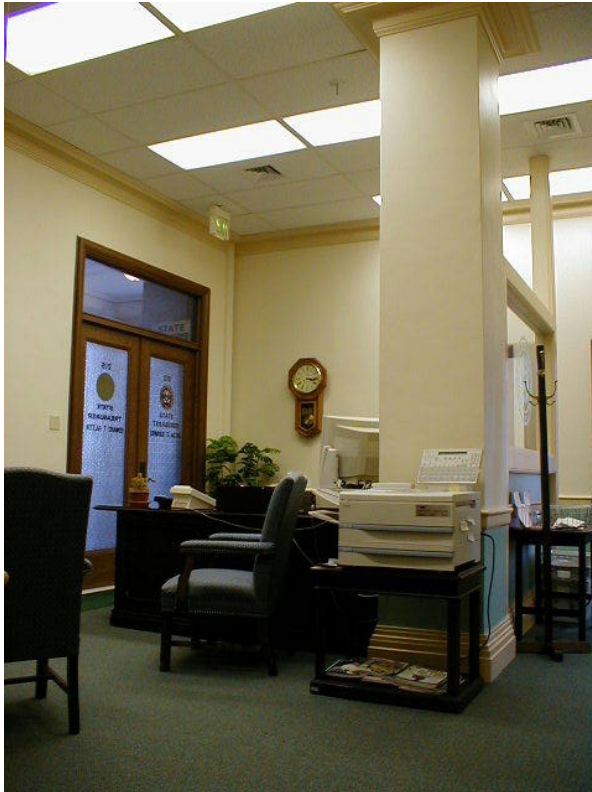
215 State Treasurer

Element	Description	Historical Significance	Notes
D-15	Wood slab door with plain wood casing (simple closet/demountable doors)	Non Contributory Qty:	To offices 214b & c
F-11	Carpeted floor, on pad	Contributory Qty:	
D-10	Metal wood-grained panel door with matching casing. Bankers glass panel and transom	Very Significant Qty:	Double doors to cooridor, Main Entry, marble threshold
CL-08	Acoustical ceiling, suspended T-bar frame	Non Contributory Qty:	
L-08	Fluorescent lights	Non Contributory Qty:	
M-11	Wood chair rail	Non Contributory Qty:	Painted
W-7	Plaster wall, painted and smooth	Significant Qty:	
B-2	Molded wood base	Contributory Qty:	Painted - 1' typ
W-8	Sheetrock wall, painted and smooth	Contributory Qty:	Various offices and wall screen with window
WN-6	Interior sidelight window, wood	Non Contributory Qty:	To office 214B
D-28	Metal wood-grained panel door with matching bollection molding	Significant Qty:	To various offices and stairwell to safe

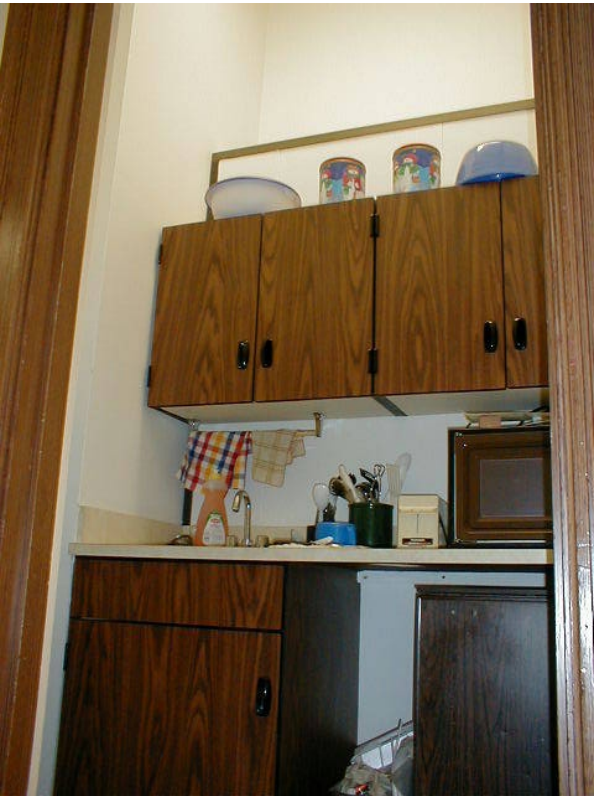
215d

Element	Description	Historical Significance	Notes
SP-3	Wood bookcase, built-in	Non Contributory Qty:	
M-19	Wood casing, new	Contributory Qty:	
B-2	Molded wood base	Contributory Qty:	
P-13	Porcelain sink	Contributory Qty:	
CL-08	Acoustical ceiling, suspended T-bar frame	Non Contributory Qty:	
F-12	Carpeted floor, glue-down	Contributory Qty:	
L-08	Fluorescent lights	Non Contributory Qty:

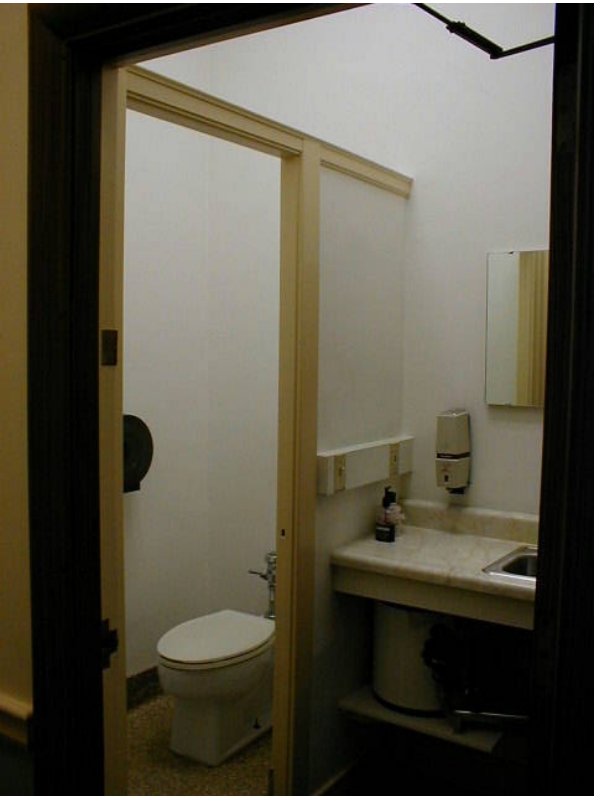
215e

Element	Description	Historical Significance	Notes
D-05	Metal wood-grained panel door with matching casing	Very Significant Qty:	
SP-3	Wood bookcase, built-in	Non Contributory Qty:	
P-13	Porcelain sink	Contributory Qty:	
P-10	Toilet, Non-original	Contributory Qty:	
CL-08	Acoustical ceiling, suspended T-bar frame	Non Contributory Qty:	
F-10	Vinyl floor	Contributory Qty:	
L-08	Fluorescent lights	Non Contributory Qty:

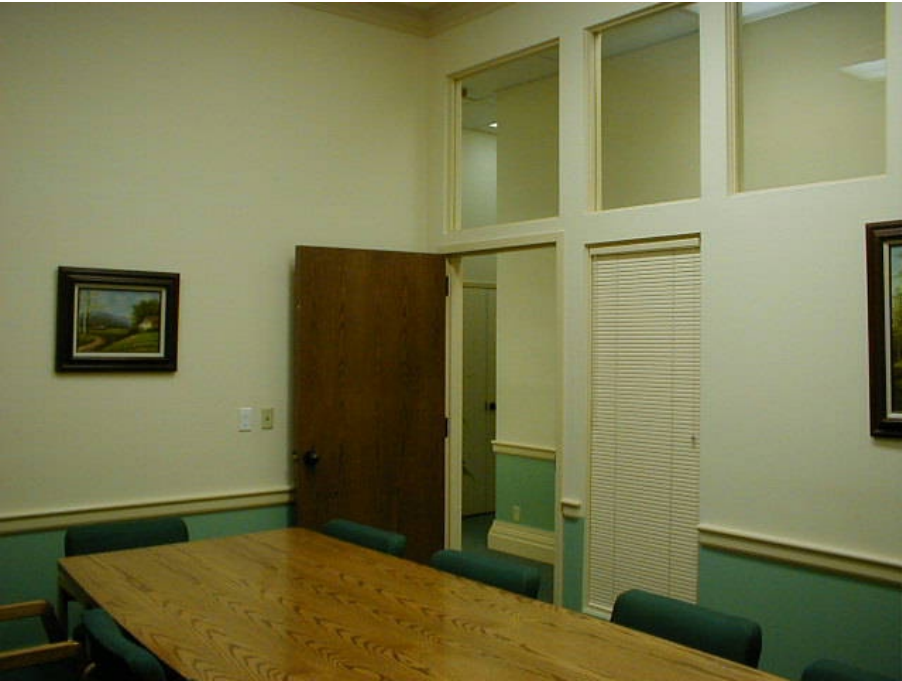
217

Element	Description	Historical Significance	Notes
D-10	Metal wood-grained panel door with matching casing. Bankers glass panel and transom	Very Significant Qty:	
D-15	Wood slab door with plain wood casing (simple closet/demountable doors)	Non Contributory Qty:	
M-11	Wood chair rail	Non Contributory Qty:	
CR-5	Wood cornice	Contributory Qty:	
B-2	Molded wood base	Contributory Qty:	Painted
E-14	fan	Non Contributory Qty:	
CL-08	Acoustical ceiling, suspended T-bar frame	Non Contributory Qty:	
F-12	Carpeted floor, glue-down	Contributory Qty:	
L-08	Fluorescent lights	Non Contributory Qty:

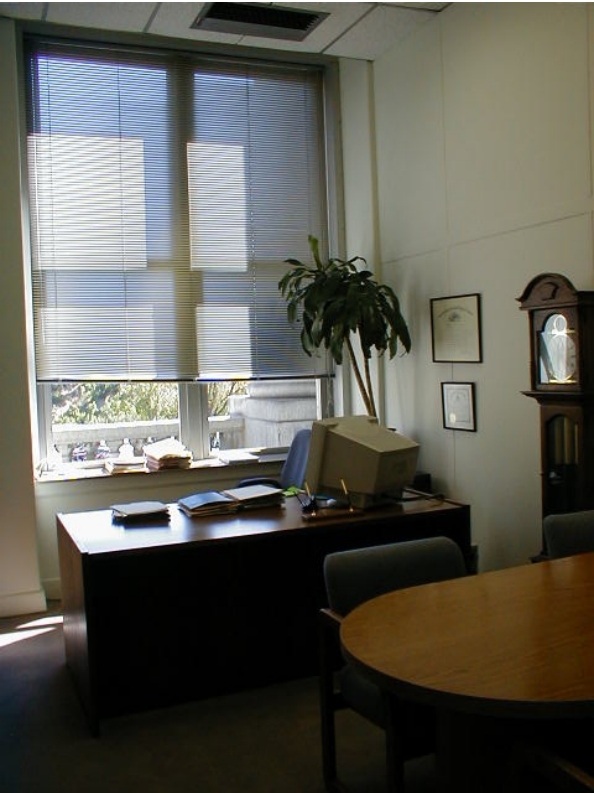
218 Office Area -Attorney General

includes all offices on south walls/south east section of office have the same details - the reception is similar to the actual Attorney General's office 218e,a & 218c/d/m/n

Element	Description	Historical Significance	Notes
D-30	Aluminum doors with glass panels and matching transoms. Swing doors to patio in corner offices.	Contributory Qty:	specific to 220g
B-4	Rubber/vinyl base	Non-Contributory Qty:	on columns
B-6	Plaster base, painted	Contributory Qty:	on actual exterior walls.(plaster walls)
CL-08	Acoustical ceiling, suspended T-bar frame	Non-Contributory Qty:	
CPP-7	Plaster pilaster, painted	Significant Qty:	has b-4
D-12	Metal wood-grained panel door with matching casing. Decorative louver transom	Contributory Qty:	
D-27	Wood slab door with etched panel look. Plain wood casing, extending up to 1/2 transom. Governor's area specific	Contributory Qty:	on plaster walls
F-11	Carpeted floor, on pad	Contributory Qty:	
L-08	Fluorescent lights	Non-Contributory Qty:	
D-19	Wood slab door with plain metal casing. (demountable wall doors)	Contributory Qty:	
W-13	Wallpapered wall, bookcloth/burlap	Contributory Qty:	on orignal N. walls - east wall open area - possibly corridor area.

W-18	demountable wall	Non-Contributory Qty:	demountable walls with transom windows above wn-3 - wood lamine panels with d-9
W-7	Plaster wall, painted and smooth	Contributory Qty:	exterior, origional walls
WN-1	Aluminum replacement window	Non Contributory Qty:	variable

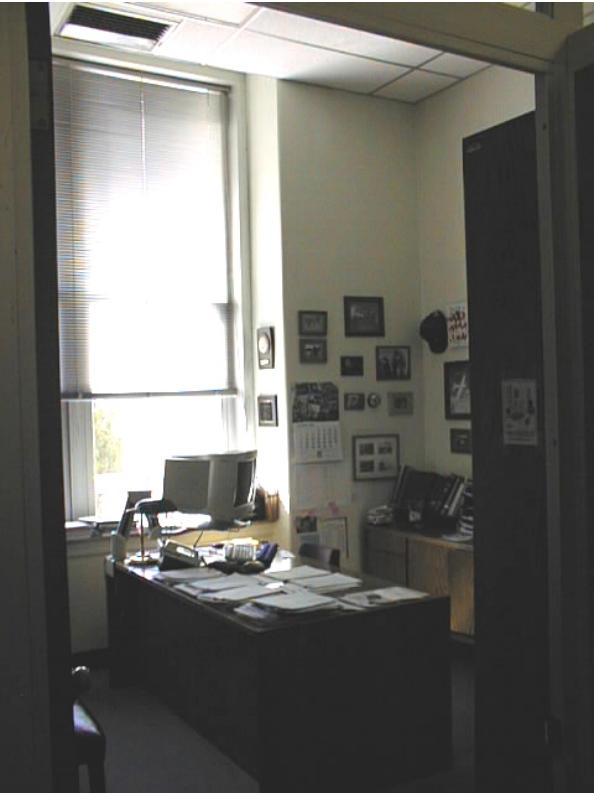
218f Attorney General Offices

Notes Includes rooms 220,a,b & 220f-j

Element	Description	Historical Significance	Notes
W-18	demountable wall	Non Contributory Qty:	
B-6	Plaster base, painted	Contributory Qty:	
CL-08	Acoustical ceiling, suspended T-bar frame	Non-Contributory Qty:	
CPP-7	Plaster pilaster, painted	Significant Qty:	
F-11	Carpeted floor, on pad	Contributory Qty:	
L-08	Fluorescent lights	Non Contributory Qty:	
D-15	Wood slab door with plain wood casing (simple closet/demountable doors)	Non-Contributory Qty:	
W-18	demountable wall	Non Contributory Qty:	
W-7	Plaster wall, painted and smooth	Contributory Qty:	
WN-1	Aluminum replacement window	Non Contributory Qty:	
WN-9	Leaded glass window, interior	Significant Qty:	Part of the demountable walls

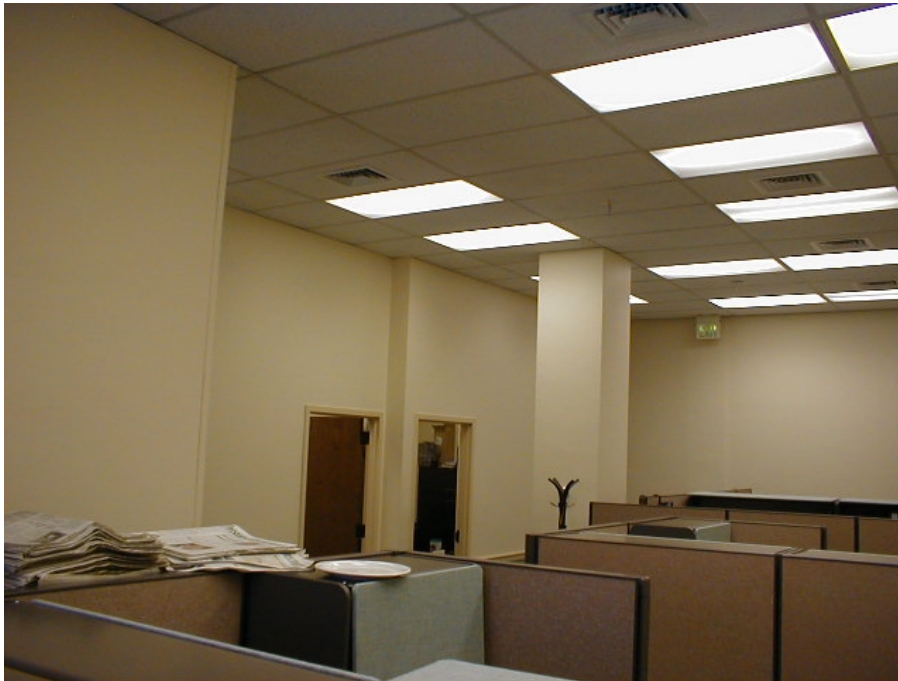
219 State Treasurer Offices

Notes includes 219a/b/c Office areas furnished with systems furniture.

Element	Description	Historical Significance	Notes
W-7	Plaster wall, painted and smooth	Very Significant Qty:	
W-8	Sheetrock wall, painted and smooth	Contributory Qty:	
D-15	Wood slab door with plain wood casing (simple closet/demountable doors)	Non Contributory Qty: 2	
D-29	Wood panel door with metal wood-grained bollection molding	Significant Qty: 1	
B-2	Molded wood base	Contributory Qty:	
M-11	Wood chair rail	Non Contributory Qty:	
D-10	Metal wood-grained panel door with matching casing. Bankers glass panel and transom	Very Significant Qty:	to main cooridoor - transom has been replaced with a vent.
CL-08	Acoustical ceiling, suspended T-bar frame	Non-Contributory Qty:	
CPP-10	Concrete	Contributory Qty:	
F-12	Carpeted floor, glue-down	Contributory Qty:	
L-08	Fluorescent lights	Non Contributory Qty:

M-16	Marble window sill, original, with molded wood skirt	Contributory Qty:
WN-1	Aluminum replacement window	Non Contributory Qty:

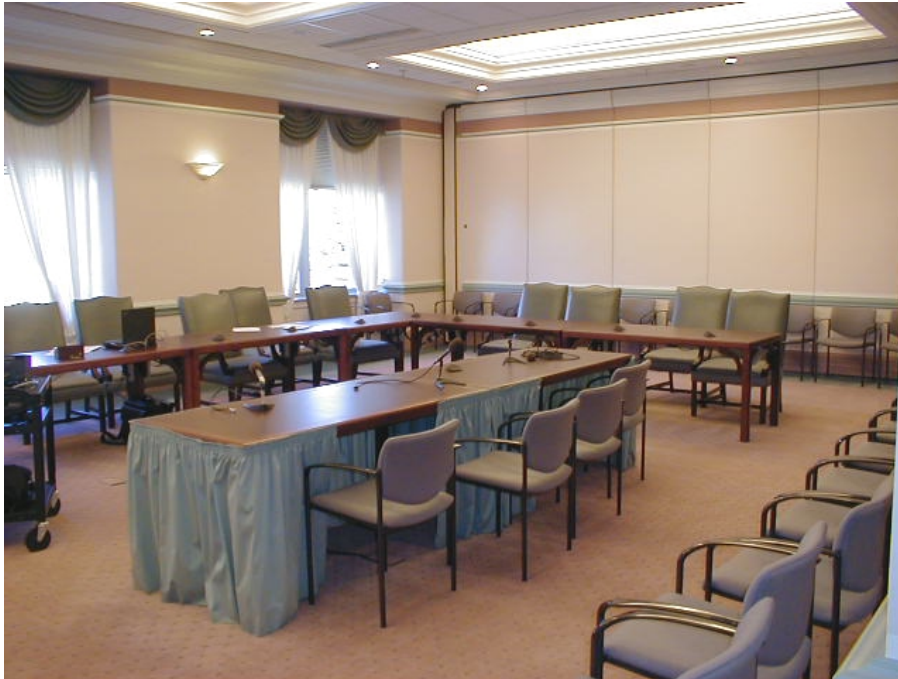
223 Committee Room

Notes includes 225

Element	Description	Historical Significance	Notes
B-2	Molded wood base	Non Contributory Qty:	Check for accuracy on description
CL-06	Sheetrock ceiling, painted	Non Contributory Qty:	
CL-08	Acoustical ceiling, suspended T-bar frame	Non Contributory Qty:	
CPP-7	Plaster pilaster, painted	Significant Qty:	
CR-2	Plaster cornice: crown molding, classical and simple	Contributory Qty:	
D-07	Wood Panel door with decorative metal wood-grained casing	Contributory Qty:	
F-11	Carpeted floor, on pad	Contributory Qty:	Has a quilted appearance - field carpet
L-12	Indirect cove lighting	Non Contributory Qty:	
L-14	Recessed lights	Non Contributory Qty:	
L-22	Wall sconce (new) frosted glass, cone-shaped	Contributory Qty:	
M-11	Wood chair rail	Non Contributory Qty:	
M-12	Wood picture rail	Non Contributory Qty:

M-20	light cove	Non Contributory Qty:
W-24	Accordion dividing wall, painted and molded as wall	Non Contributory Qty:
W-7	Plaster wall, painted and smooth	Contributory Qty:
W-8	Sheetrock wall, painted and smooth	Contributory Qty:
WN-1	Aluminum replacement window	Non Contributory Qty:

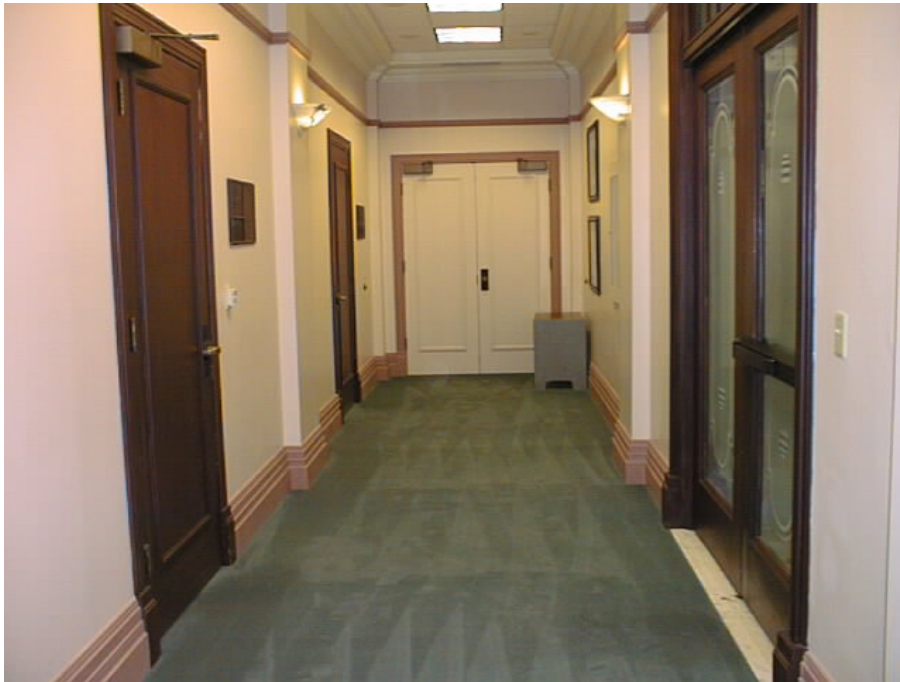
224 Hall to Committee Room

Element	Description	Historical Significance	Notes
B-2	Molded wood base	Contributory Qty:	Check for accuracy on description
CL-06	Sheetrock ceiling, painted	Non Contributory Qty:	
CL-08	Acoustical ceiling, suspended T-bar frame	Non Contributory Qty:	
CPP-7	Plaster pilaster, painted	Significant Qty:	
CR-2	Plaster cornice: crown molding, classical and simple	Contributory Qty:	
D-07	Wood Panel door with decorative metal wood-grained casing	Contributory Qty:	
F-11	Carpeted floor, on pad	Contributory Qty:	Has a quilted appearance - field carpet
F-12	Carpeted floor, glue-down	Contributory Qty:	Border only
L-12	Indirect cove lighting	Non Contributory Qty:	
L-14	Recessed lights	Non Contributory Qty:	
L-22	Wall sconce (new) frosted glass, cone-shaped	Contributory Qty: 6	
M-11	Wood chair rail	Non Contributory Qty:	
M-12	Wood picture rail	Non Contributory Qty:	
M-20	light cove	Non Contributory Qty:	
W-24	Accordion dividing wall, painted and molded as wall	Non Contributory Qty:

W-7	Plaster wall, painted and smooth	Contributory Qty:
W-8	Sheetrock wall, painted and smooth	Contributory Qty:
WN-1	Aluminum replacement window	Non Contributory Qty:
